Leaks in Driscopipe® 8000 Pipes Attributed to Plastic Contamination

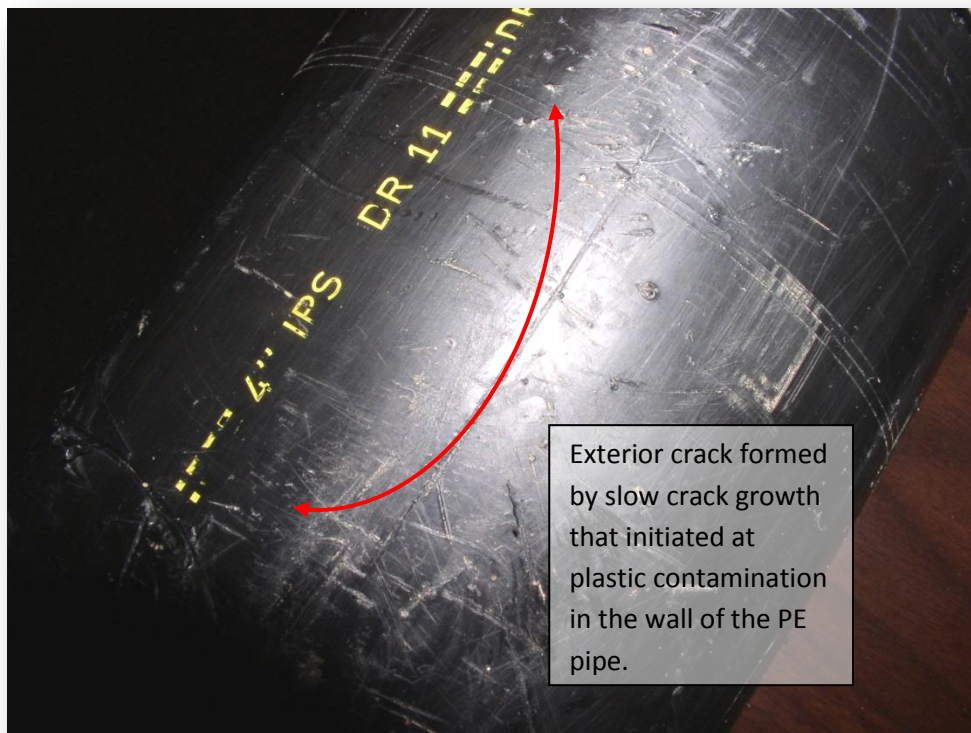
Since the letter was issued, we have received a small number of additional reports of detected leaks that have been attributed to slow crack growth initiating at the site of the contamination in the polyethylene pipe wall. There have been no reports of incidents or major leaks. Further, there have been no reports of leaks attributed to contamination in tubing sizes ($\leq 1\text{-}1/4\text{'')$).

Driscopipe® 8000 pipes were solid black PE3408 pipes with burnished gloss surface with a yellow print line. The pipe was available in sizes from 1/4" through 8" diameter. Figure 1 is an example of the exterior appearance of a leak formed due to contamination.

Figure 1
Example of a leak that formed due to contamination of the polyethylene pipe

If a leak has been found, determining if the leak was caused by plastic contamination is done visually by a microscopic inspection of the fracture surface. The plastic contaminant will appear as a film in the interior of the pipe wall thickness. Leaks can be detected through leak surveys.
