Electrofusion of Driscopipe® 8000 Pipes

Identifying Driscopipe® 8000 Pipes

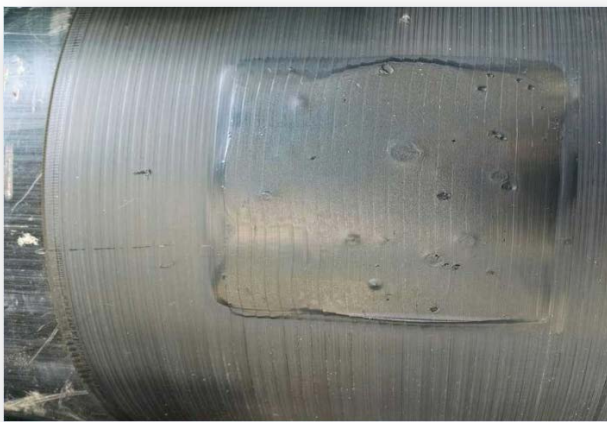
Driscopipe®8000 pipes were solid black PE3408 pipes with burnished gloss surface and a yellow print line. The pipe was available in sizes from ¼” through 8” diameter. Figure 1 is an example of the exterior appearance of bubbling formed during an attempted electrofusion joint.

Example of a melt pattern from a saddle heater used to pre-test for an electrofusion coupling

ASTM D2513 section X2.7.2.2 recommends that mechanical fittings be used to join pipes that show signs of bubbling that may be the result of a liquid hydrocarbon release. Significant bubbling of the ID or OD surfaces, whether caused by liquid hydrocarbon release, electrofusion or otherwise, may have affected the integrity of the pipe joint.

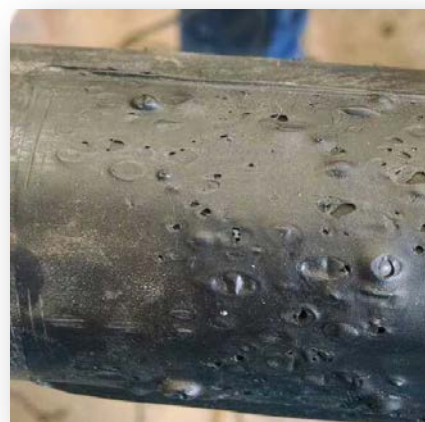
Figure 2

Increase in bubbling after extended heat time
