Troubleshooting the Extrusion Coating Process

Chevron Phillips Chemical is pleased to offer useful extrusion coating troubleshooting tips. However, due to the complexity of production and manufacturing, these tips should be used only as rough guidelines and suggestions. Implementation of any of these troubleshooting tips could affect the finished properties of the final product and should never be implemented without proper safety considerations. Further, they are not a substitute for your own expertise.

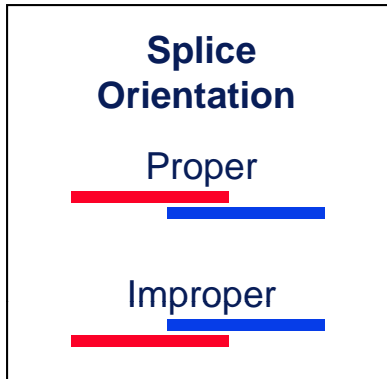
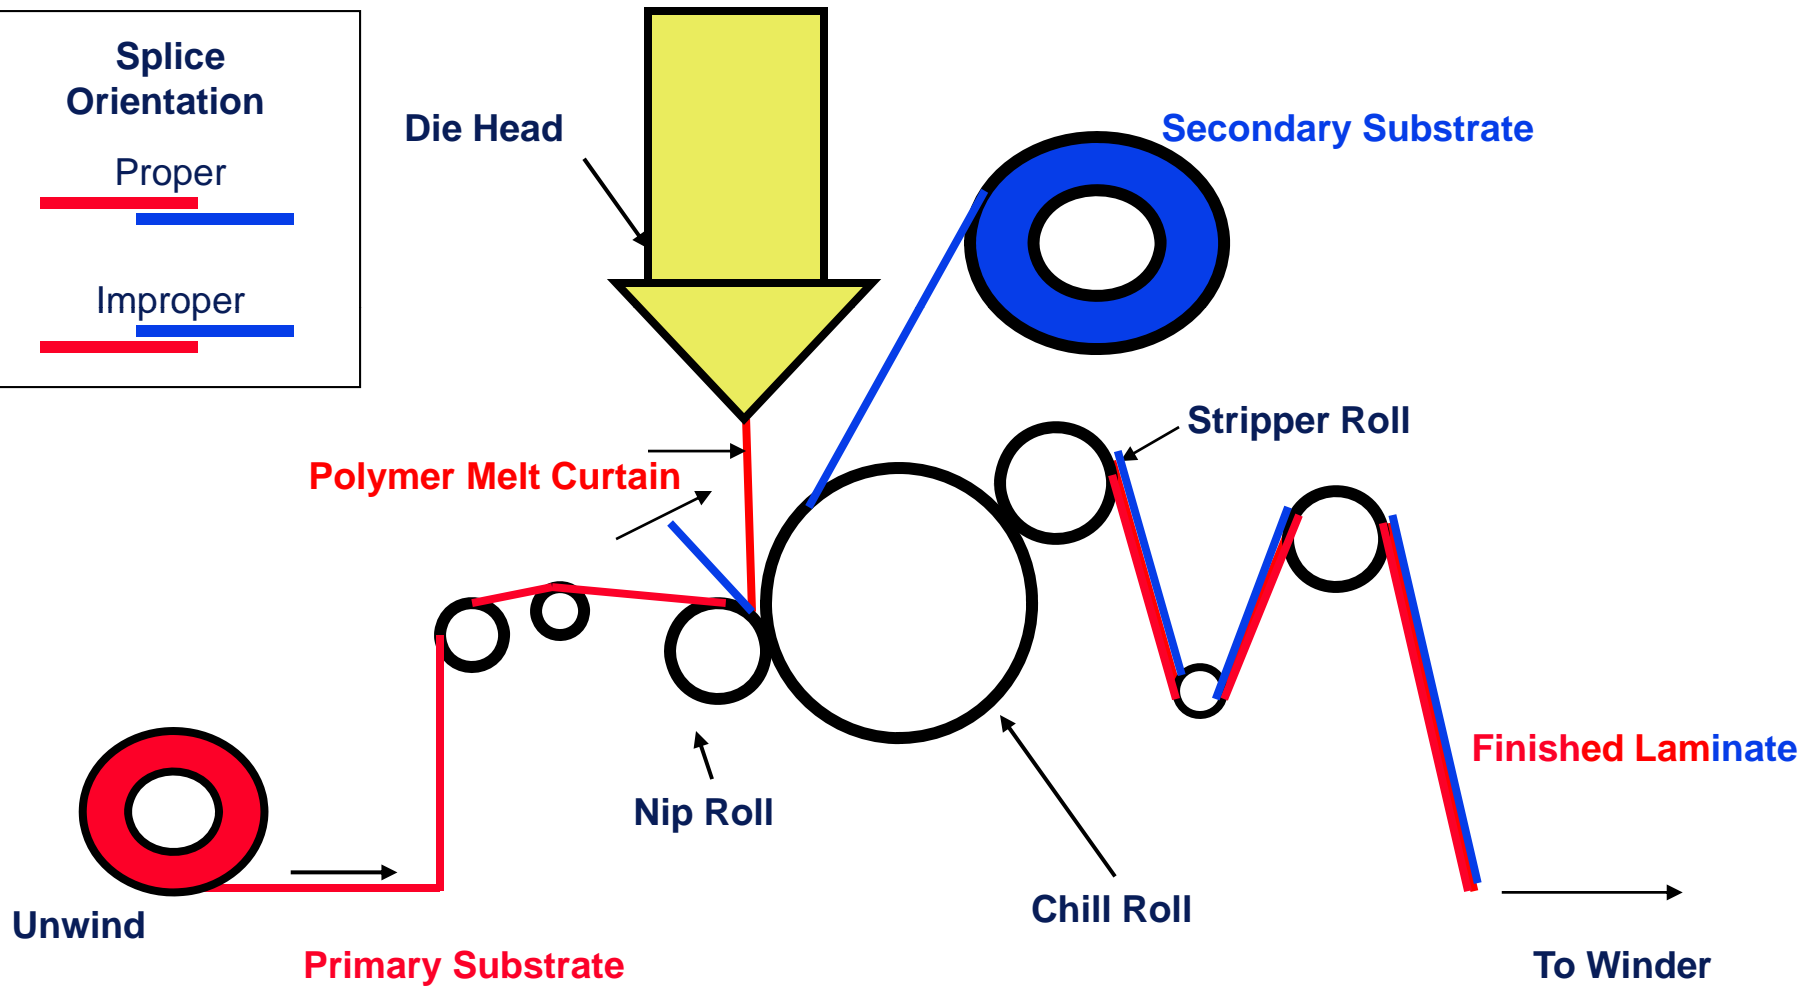
Splice Orientation

- Increase resin melt temperature
- Use resin with higher melt index
- Decrease off set between internal deckle settings.
- Decrease die gap, Increase coat weight.
- Reverse splice direction or implement mechanical solution
